**A RECONNAISSANCE REPORT
ON
THE 2007 SINGKARAK LAKE (SOLOK) EARTHQUAKE
WITH
AN EMPHASIS ON THE SEISMIC ACTIVITY OF SUMATRA FAULT
FOLLOWING 2004 and 2005 GREAT OFF-SUMATRA EARTHQUAKES**

Ömer AYDAN

**Earthquake Disaster Investigation Sub-Committee
Japan Society of Civil Engineers
(Tokai University, Department of Marine Civil Engineering, Shizuoka)**

August 2007

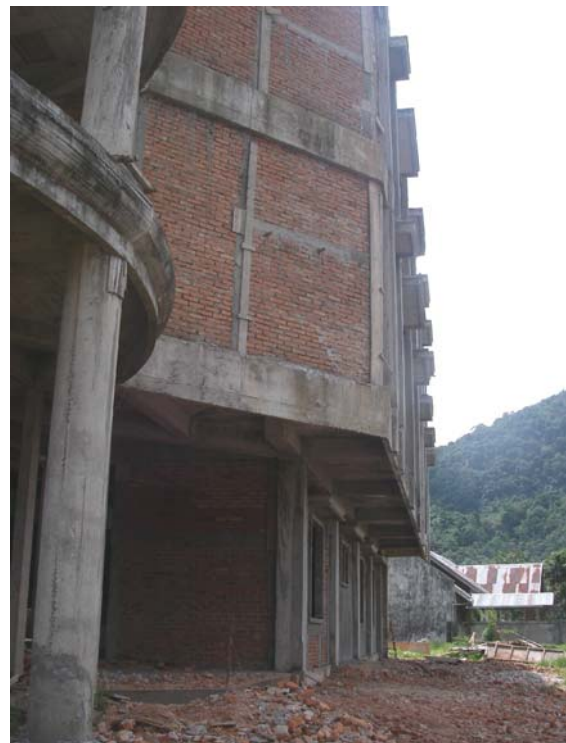
RC buildings with two or three stories suffered heavily from the earthquake. The reinforced concrete structures are framed structures with integrated or non-integrated in-fill walls. The reinforcing bars are generally smooth and infill walls are built with red-burned solid clay bricks using mortar. The floor height in the region ranges between 3 to 4m. The inspections of the reinforced concrete buildings indicated that they are mainly failed in the pancake mode. RC buildings are generally found in cities and large towns. The concrete buildings having 2 or more stories were either collapsed or heavily damaged. The causes of damage to RC buildings are similar to those observed in other recent earthquakes in Indonesia and elsewhere (Figures 5.4 and 5.5). They be re-stated for this earthquake as follows:

Figure 5.5. Some typical damage to RC buildings

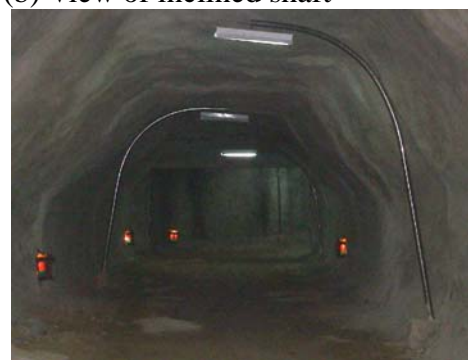
The configuration of adits changes from location to location and their functions. The inclined shaft has arched roof and it is 2.4m high and 3.0m wide (Figure 7.4). The main adits has a trapez shape with a height ranging between 1.8 to 2.1m and its base width ranges 2.4 to 2.6m. The rooms between adits are larger and their width is about 4m with a height of 2m.

Figure 7.4. Some views of the inclined shaft and adits and rooms in the shelter

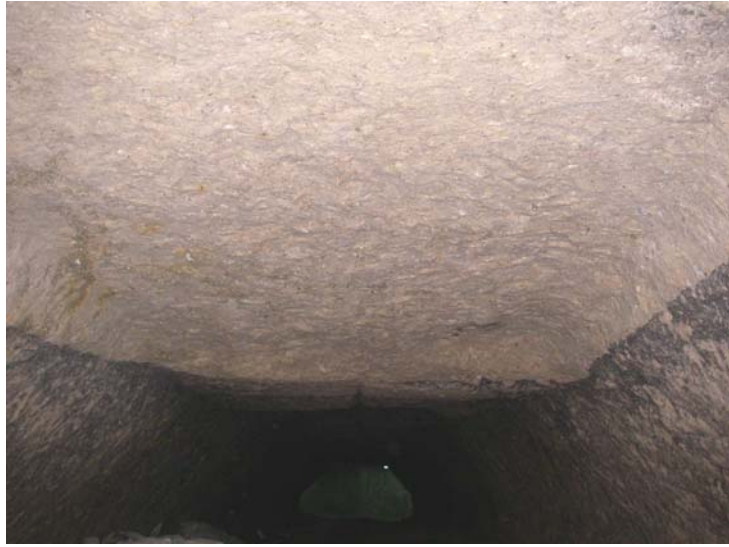
Location 2

acceleration to cause the slope failures was estimated to be more than 0.2g. The other estimations yielded similar values (see Sub-section 4.5). In spite of such high ground motions, the weak rock conditions and extensive slope failures, the underground shelter was almost intact after the earthquake. The author found three locations where some damaging effects of the earthquake on the underground shelter were observed (Figure 7.5). The first location was at the first room with a base width of 3.8m near the bottom of the inclined shaft and a 10-20cm thick slab of rock was fallen from the roof for a length of 5m. The rock layer belongs to the pyroclastic flow deposit layer 1. The second location was at the ventilation adit next to slope. A 40-50cm thick rock slab was fallen from the roof for a length of 2m and semi-ruptured roof material could be observed. A 100cm long and 5cm wide spalling occurred at a room with base width of 3.8m was observed. Except these three locations there was no visible damage to the underground shelter.

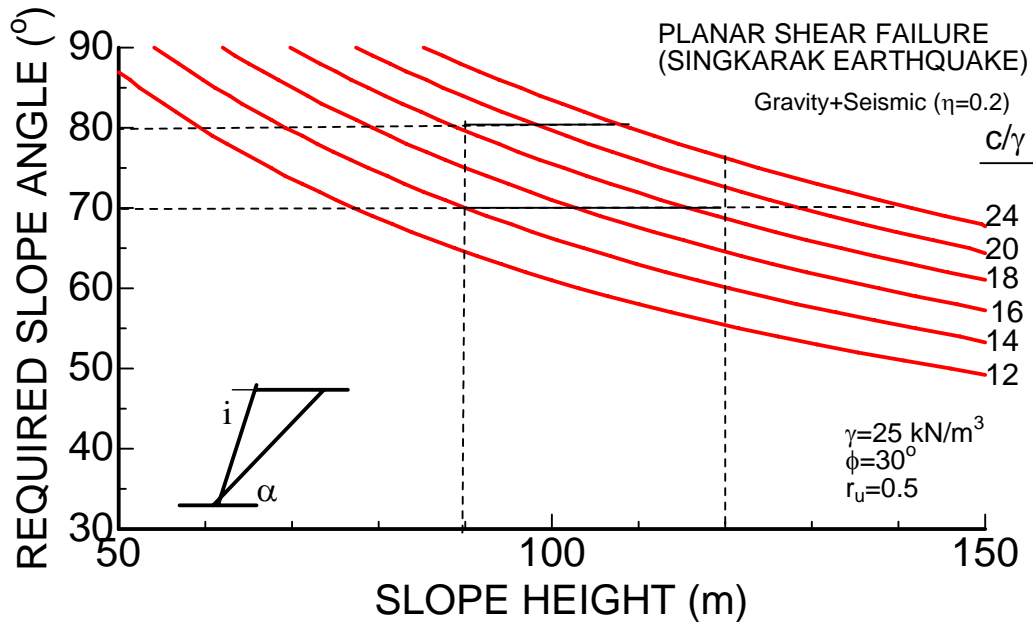
Using the seismic coefficient method and assuming that the failure is planar, and the friction angle of the ground is 30° and pore water coefficient of 0.5, the relation between slope angle and slope height can be obtained as a function of normalised cohesion to the unit weight of rock for a seismic coefficient of 0.2 as shown in Figure 8.5. In view of the self-standing underground shelter discussed in the previous section and the observed slope heights (80-120m), the most likely normalized cohesion by the unit weight is likely to be about 20 . For this value of the normalized cohesion, the value of seismic coefficient varied between 0.2 to 0.3 by an increment of 0.5 (Figure 8.6). From these parametric computations, the expected

maximum ground acceleration is likely to be around 0.25g. There is no doubt that it will be desirable to carry out detailed geotechnical investigations for determining the properties of ground around Sianok Valley. Nevertheless, the results from these parametric studies would be quite close to the actual values in view of ground conditions in similar type geological and geotechnical environments.

Figure 8.5. The relation between slope angle and slope height as a function of normalized cohesion by unit weight

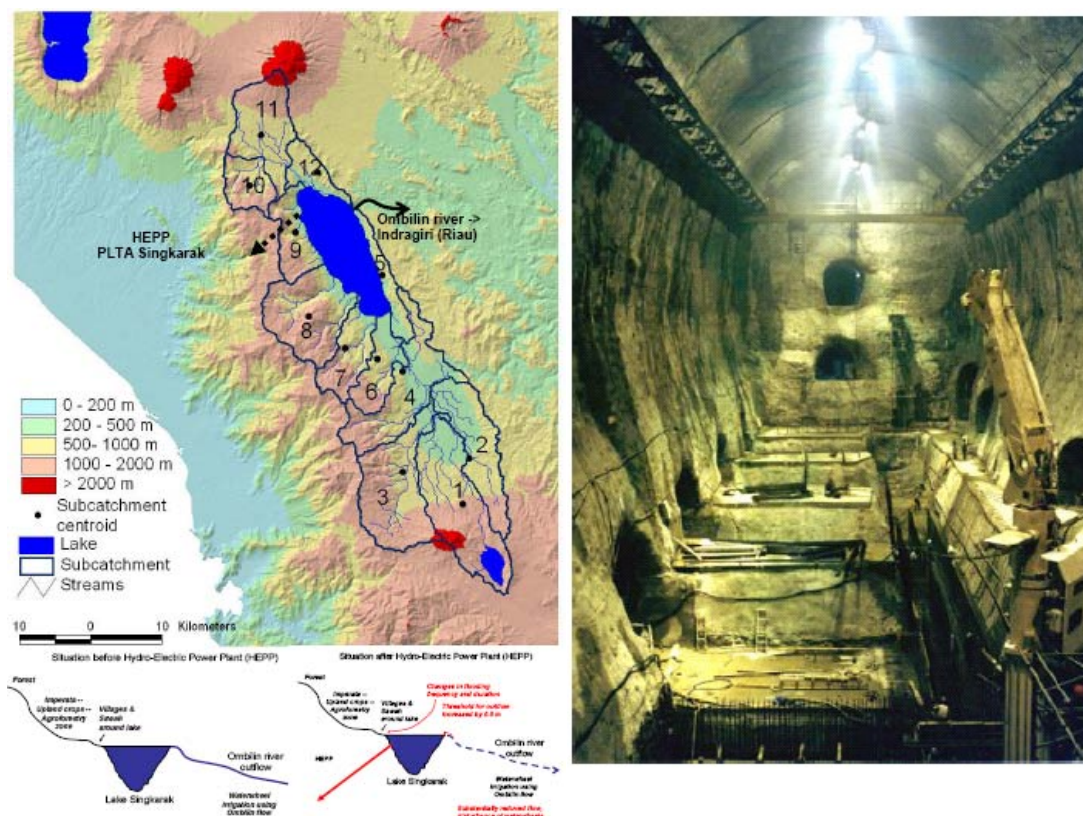
(a) Layout and location of HEPP (b) Underground power house
Figure 8.1. Singkarak hydro-electric power plant

Singkarak hydro-electric power plant was completed in 1998. The hydro-electric power plant has involved an underground power house (station), small dam and 16.5 km long head-race tunnel. The HEPP of Singkarak in Pariaman is at 32 km east of Padang and it was developed to provide electric power of 175 MW. The supply water from Singkarak Lake is flowed through a head-race tunnel as long as 16.5 km with inner diameter of 5.0 m (excavation diameter 6.2 m) (Figure 10.1(a)). The method applied for the development of this tunnel was based on The New Austrian Tunneling Methods (NATM). During the construction period, Tunnel Boring Machine was used in the first time in Indonesia. In the Singkarak Hydroelectric Project in Indonesia, anchored crane beams have been installed directly against the rock face, which is gneiss of reasonable quality. This installation is shown in the photograph reproduced in Figure 10.1(b), taken during construction of the cavern.

There was no damage to the Singkarak hydro-electric power plant by the earthquake. The electricity production was back after an automatic shut-down of the plant due to ground shaking.

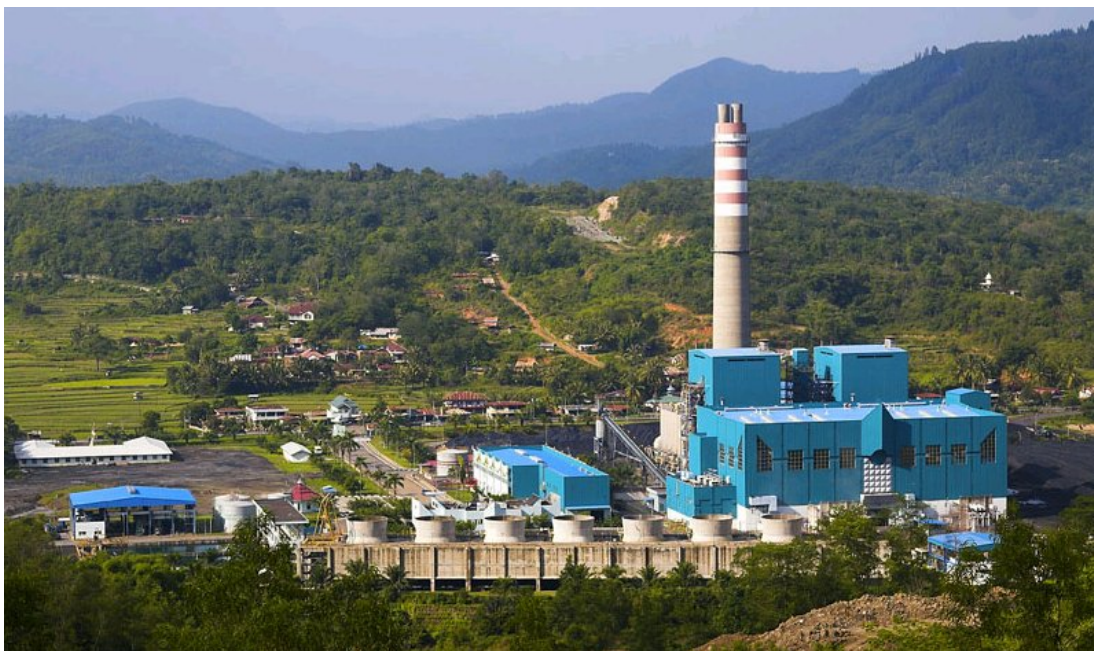
Figure 10.4. A view of Kandi Thermo-electric Power Plant

Another major power plant in the epicentral area is Kandi Thermo-electric Power Plant near Sawahlung (Figure 10.4). The coal to this plant was supplied from underground mine at Sawahlung and it was shut down with the closure of the mine. There was no report of damage to this shut-down thermo-electric power plant by the earthquake.

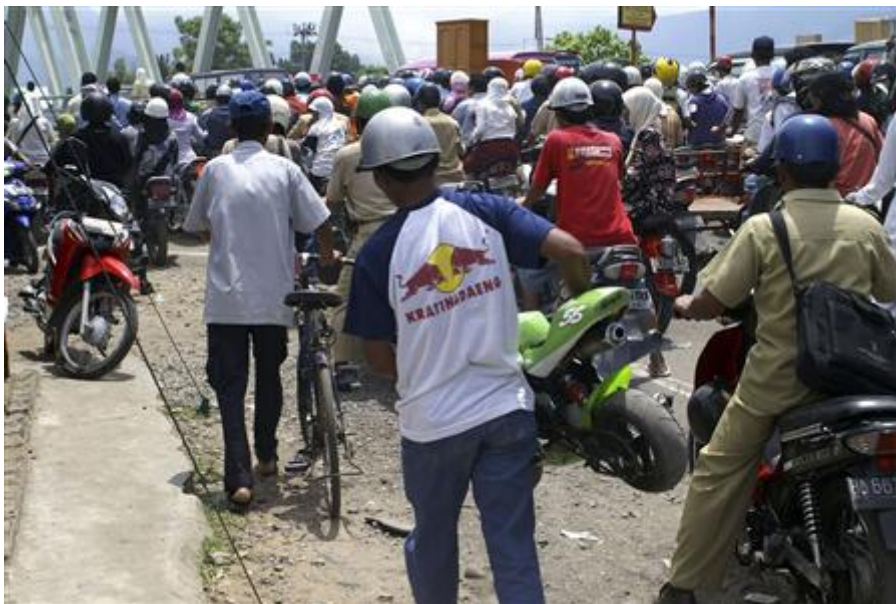
Figure 11.2. Panic in Padang city following 2007 Singkarak Lake earthquake

The second important issue is the release of the accurate information to the public as soon as earthquakes occur. Meteorology and Geophysics Agency (BMG) of Indonesia is responsible for releasing such information. However, this agency failed to release such information in most recent earthquakes of 2004 Aceh, 2005 Nias, and 2006 South Java as well as 2007 Singkarak (Solok) earthquake. The information must be provided to public at most in 5 minutes time. The system must be capable of if earthquake has the potential for causing tsunami. If so, it should provide information on expected arrival time and tsunami height. The system used in Japan is probably the most effective one so far in the world. There was a huge panic in Padang city since people did not get information about the location, magnitude and its potential for causing tsunami in due time by Meteorology and Geophysics Agency (BMG) of Indonesia. In spite of drills, the people tended to use vehicles, motorbikes, bicycles causing traffic jams (Figure 11.2).
